# Access Compliance Report Public Rights-of-Way (Curb Ramps)

Main Street: NEWKIRK\_RD Cross Street: WELDON\_HEIGHTS Location: SE

ADA ID: RPAT211104132535 Ramp Type: Type 4 - Parallel Initial Pass/Fail: Fail Overall Compliance: No Severity Score: 32

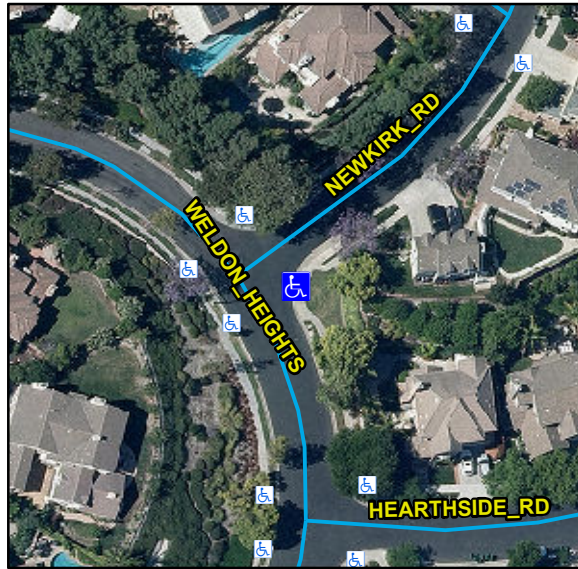
| Compliance | Description | Data | Compliance | Description | Data |
|---|---|---|---|---|---|
| N/A | Ramp Length LT (in) | 83 | N/A | Ramp Length RT (in) | 86 |
| Yes | Ramp Width LT (in) | 53 | Yes | Ramp Width RT (in) | 54 |
| No | Ramp Run Slope LT (%) | 16 | Yes | Ramp Run Slope RT (%) | 1.3 |
| No | Ramp Cross Slope LT (%) | 2.6 | No | Ramp Cross Slope RT (%) | 2.3 |

Remove & Replace Curb Ramp With Two New Directional Ramps or Equivalent.

R204.3, R304.3.2, R304.5.3, STD 1115

Total Cost: \$ 4000
