# Access Compliance Report Public Rights-of-Way (Curb Ramps)

| Main Street: NEWKIRK_RD | | Cross Street: SAYBROOKE_LN | | Location: | W |
| ADA ID: RPAT211104132859 | Ramp Type: Type 4 - Parallel | Initial Pass/Fail: Fail | Overall Compliance: No | Severity Score: | 30 |

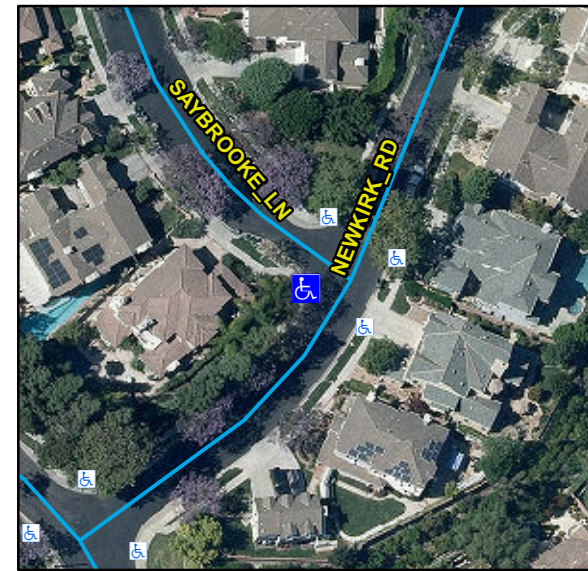
| Compliance | Description | Data | Compliance | Description | Data |
|---|---|---|---|---|---|
| Yes | Ramp Run Slope LT (%) | 1.9 | No | Ramp Run Slope RT (%) | 12.8 |

**Remove & Replace Curb Ramp With Two New Directional Ramps or Equivalent.**

**R204.3, R304.3.2, STD 1115**

Total Cost: \$ 4000
