# Access Compliance Report Public Rights-of-Way (Curb Ramps)

| Main Street: SAYBROOKE_LN | | Cross Street: NEWKIRK_RD | | Location: | N |
| ADA ID: RPAT211104133108 | Ramp Type: Type 4 - Parallel | Initial Pass/Fail: Fail | Overall Compliance: No | Severity Score: | 15 |

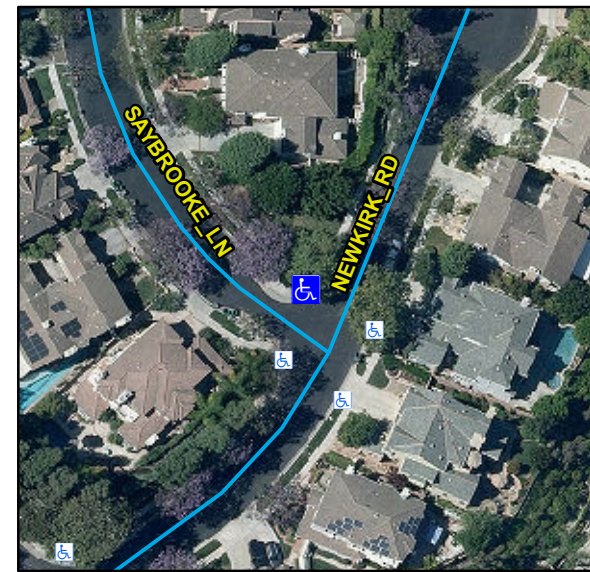
| Compliance | Description | Data | Compliance | Description | Data |
|---|---|---|---|---|---|
| Yes | Ramp Run Slope LT (%) | 2.5 | No | Ramp Run Slope RT (%) | 11.7 |

**Remove & Replace Curb Ramp With Two New Directional Ramps or Equivalent.**

**R204.3, R304.3.2, STD 1115**

Total Cost: \$ 4000
