# Access Compliance Report Public Rights-of-Way (Curb Ramps)

| Main Street: HEARTHSIDE_RD | Cross Street: BRYNWOOD_LN | Location: | SE |

| ADA ID: RPAT211104134152 | Ramp Type: Type 4 - Parallel | Initial Pass/Fail: Fail | Overall Compliance: No | Severity Score: | 16 |

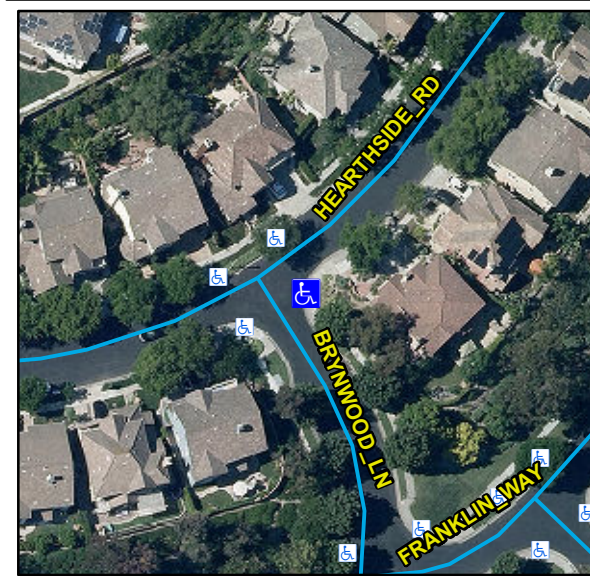
| Compliance | Description | Data | Compliance | Description | Data |
|---|---|---|---|---|---|
| No | Ramp Run Slope LT (%) | 9 | Yes | Ramp Run Slope RT (%) | 0.6 |
| No | Ramp Cross Slope LT (%) | 2.5 | Yes | Ramp Cross Slope RT (%) | 2 |

Possible Solutions:  
**Remove & Replace Curb Ramp With Two New Directional Ramps or Equivalent.**

OC Std/PROW:  
**R304.3.2, R304.5.3, STD 1115**

Total Cost: \$ 4000
