# Access Compliance Report Public Rights-of-Way (Curb Ramps)

Main Street: BRYNWOOD\_LN Cross Street: FRANKLIN\_WAY Location: NE

ADA ID: RPAT211104134450 Ramp Type: Type 4 - Parallel Initial Pass/Fail: Fail Overall Compliance: No Severity Score: 30

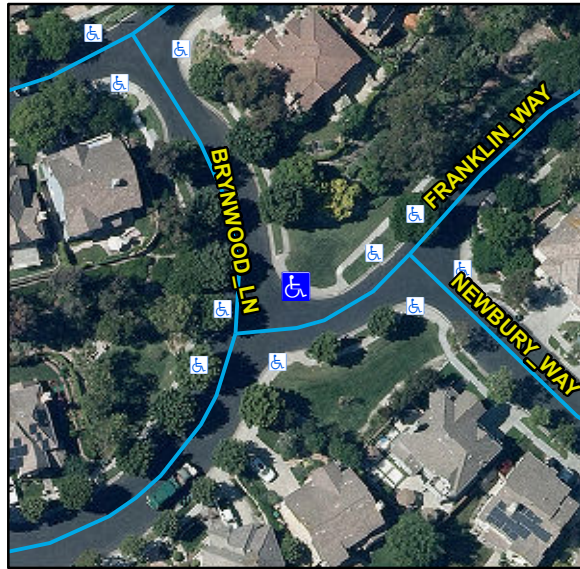
| Compliance | Description | Data | Compliance | Description | Data |
|---|---|---|---|---|---|
| No | Ramp Run Slope LT (%) | 19.9 | No | Ramp Run Slope RT (%) | 8.5 |

Remove & Replace Curb Ramp With Two New Directional Ramps or Equivalent.
