# Access Compliance Report Public Rights-of-Way (Curb Ramps)

Main Street: FRANKLIN\_WAY Cross Street: BRYNWOOD\_LN Location: SE

ADA ID: RPAT211104134717 Ramp Type: Type 4 - Parallel Initial Pass/Fail: Fail Overall Compliance: No Severity Score: 15

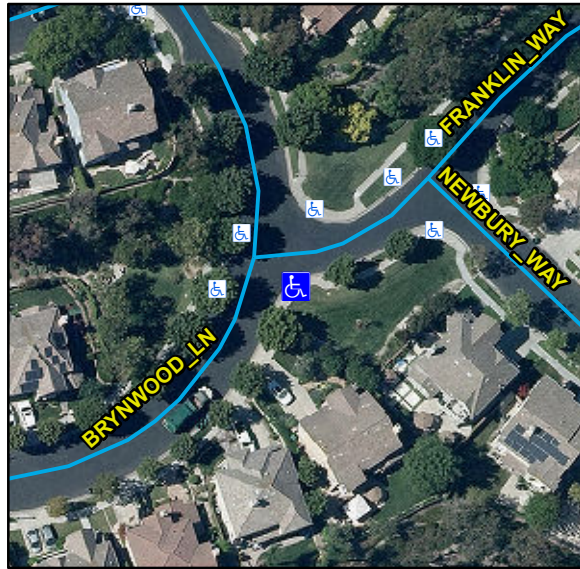
| Compliance | Description | Data | Compliance | Description | Data |
|---|---|---|---|---|---|
| No | Ramp Run Slope LT (%) | 9.1 | Yes | Ramp Run Slope RT (%) | 1.8 |

Remove & Replace Curb Ramp With Two New Directional Ramps or Equivalent.

R304.3.2, STD 1115
