# Access Compliance Report Public Rights-of-Way (Curb Ramps)

Main Street: FRANKLIN\_WAY Cross Street: NEWBURY\_WAY Location: SE

ADA ID: RPAT211104135205 Ramp Type: Type 4 - Parallel Initial Pass/Fail: Pass Overall Compliance: No Severity Score: 15

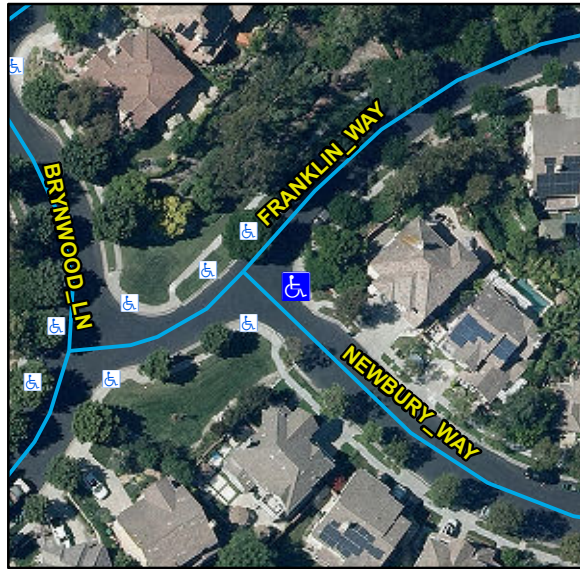
| Compliance | Description | Data | Compliance | Description | Data |
|---|---|---|---|---|---|
| N/A | Landing Present | Yes | No | DWS Provided | No |
| No | Gutter Run Slope (%) | 7.5 | | Road Cross Slope (%) | 6.7 |
| No | Gutter Cross Slope (%) | 3.1 | No | Perpendicular Joint Present | No |

**Remove & Replace Curb Ramp With Two New Directional Ramps or Equivalent. Remove & Replace Gutter.**

**R204.3, R305, R304.5.4, R304.5.3, STD 1115**
