# Access Compliance Report Public Rights-of-Way (Curb Ramps)

| Main Street: WELDON_HEIGHTS | | Cross Street: HEARTHSIDE_RD | | Location: | NE |
| ADA ID: RPAT211104140746 | Ramp Type: Type 4 - Parallel | Initial Pass/Fail: Fail | Overall Compliance: No | Severity Score: | 32 |

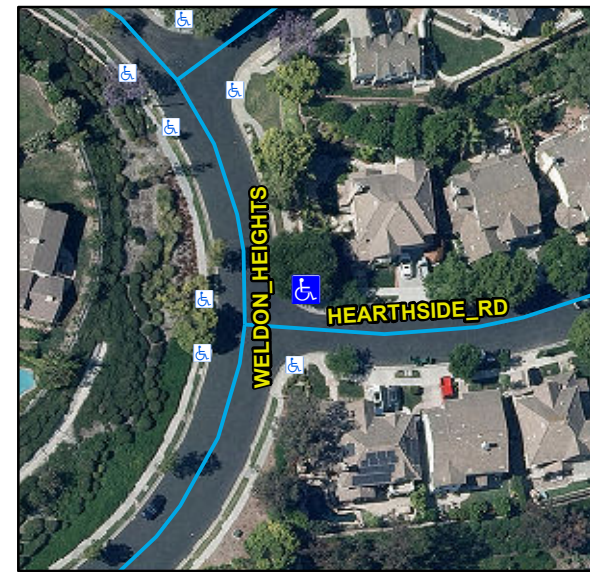
| Compliance | Description | Data | Compliance | Description | Data |
|---|---|---|---|---|---|
| No | Ramp Run Slope LT (%) | 12.1 | Yes | Ramp Run Slope RT (%) | 1.1 |
| No | Ramp Cross Slope LT (%) | 4.2 | No | Ramp Cross Slope RT (%) | 3.5 |

**Remove & Replace Curb Ramp With Two New Directional Ramps or Equivalent.**

**R204.3, R304.3.2, R304.5.3, STD 1115**
