# Access Compliance Report Public Rights-of-Way (Curb Ramps)

Main Street: HEARTHSIDE\_RD Cross Street: WELDON\_HEIGHTS Location: SE

ADA ID: RPAT211104141112 Ramp Type: Type 4 - Parallel Initial Pass/Fail: Fail Overall Compliance: No Severity Score: 16

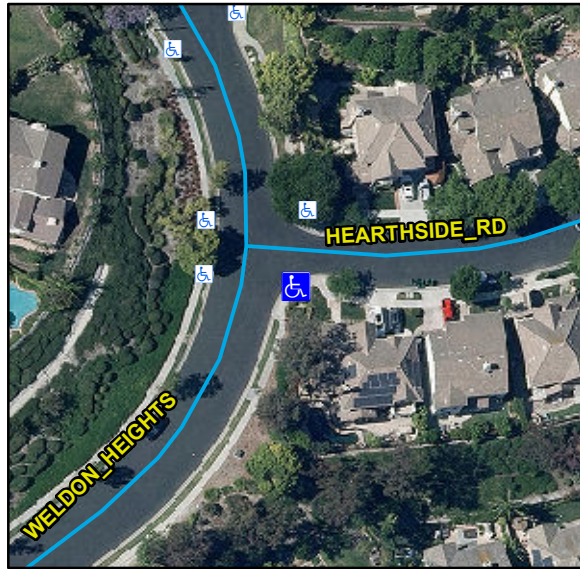
| Compliance | Description | Data | Compliance | Description | Data |
|---|---|---|---|---|---|
| No | Ramp Run Slope LT (%) | 9.5 | Yes | Ramp Run Slope RT (%) | 0.9 |
| No | Ramp Cross Slope LT (%) | 4.2 | No | Ramp Cross Slope RT (%) | 3 |

**Remove & Replace Curb Ramp With Two New Directional Ramps or Equivalent.**

**R204.3, R304.3.2, R304.5.3, STD 1115**
