# Access Compliance Report Public Rights-of-Way (Curb Ramps)

Main Street: TIFFANY\_PL Cross Street: DEL\_REY\_DR Location: NE

ADA ID: RPAT211108142353 Ramp Type: Type 1 - Perpendicular Diagonal Initial Pass/Fail: Pass Overall Compliance: No Severity Score: 2

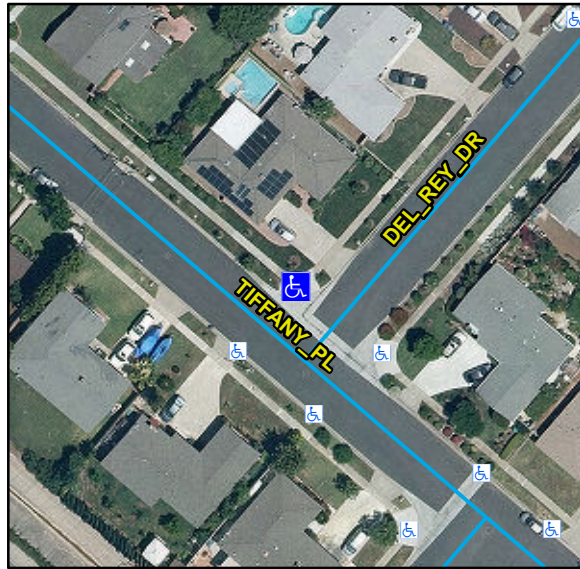
| Compliance | Description | Data | Compliance | Description | Data |
|---|---|---|---|---|---|
| N/A | Ramp Length (in) | 77 | N/A | Flare Type LT | |
| Yes | Ramp Width (in) | 48 | | | Sloped |
| Yes | Ramp Run Slope (%) | 7.4 | N/A | Flare Slope LT (%) | 7 |
| Yes | Ramp Cross Slope (%) | 0.7 | N/A | Flare Traversable LT | No |
| Yes | Gutter Ponding | No | No | Curb Slope | 6.2 |

Remove & Replace Curb Ramp With Two New Directional Ramps or Equivalent.

R304.2.2, R304.2.1, STD 1115

Total Cost: \$ 6160
