# Access Compliance Report Public Rights-of-Way (Curb Ramps)

| Main Street: DEL_REY_DR | | Cross Street: TIFFANY_PL | | Location: | E |
| ADA ID: RPAT211108142855 | Ramp Type:Type 1 - Perpendicular Diagonal Initial Pass/Fail: Fail | | Overall Compliance: No | Severity Score: | 15 |

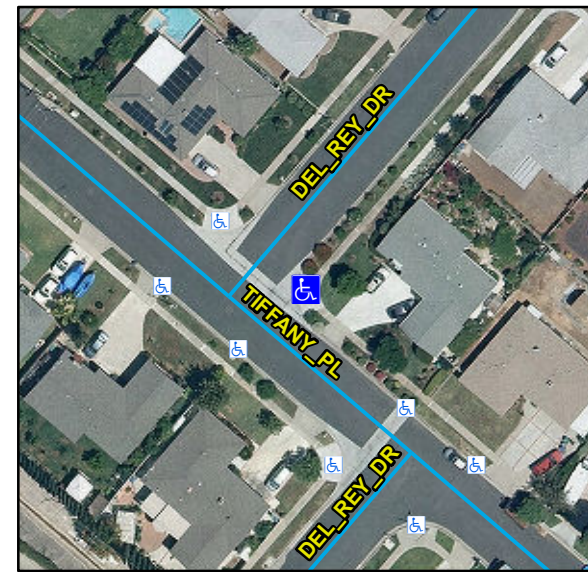
| Compliance | Description | Data | Compliance | Description | Data |
|---|---|---|---|---|---|
| No | Ramp Run Slope (%) | 8.7 | N/A | Flare Slope LT (%) | N/A |

**Remove & Replace Curb Ramp With Two New Directional Ramps or Equivalent.**

**R304.2.2, STD 1115**
