# Access Compliance Report Public Rights-of-Way (Curb Ramps)

| Main Street: CHAPLET_PL | | Cross Street: TIFFANY_PL | | Location: | E |
| ADA ID: RPAT211108143436 | Ramp Type: Type 4 - Parallel | Initial Pass/Fail: Fail | Overall Compliance: No | Severity Score: | 2 |

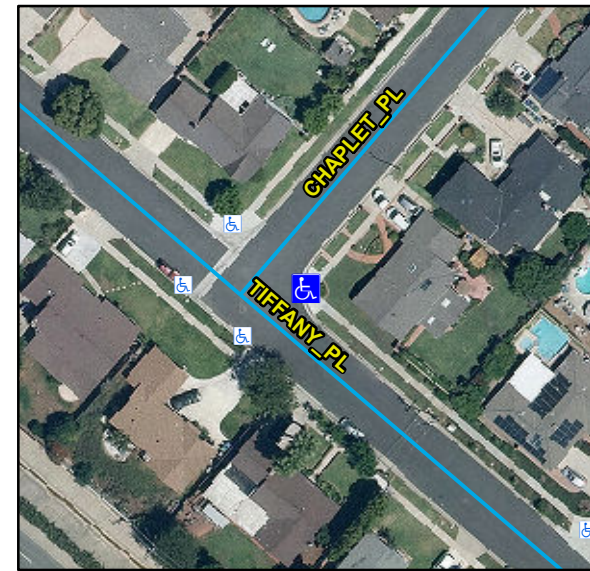
| Compliance | Description | Data | Compliance | Description | Data |
|---|---|---|---|---|---|
| Yes | Ramp Cross Slope LT (%) | 0.5 | No | Ramp Cross Slope RT (%) | 2.8 |

**Remove & Replace Curb Ramp With Two New Directional Ramps or Equivalent.**

**R304.5.3, STD 1115**

Total Cost: \$ 4000
