# Access Compliance Report Public Rights-of-Way (Curb Ramps)

| Main Street: KENNETH_DR | | Cross Street: CHAPLET_PL | | Location: | N |
| ADA ID: RPAT211108145058 | Ramp Type: Type 4 - Parallel | Initial Pass/Fail: Fail | Overall Compliance: No | Severity Score: | 2 |

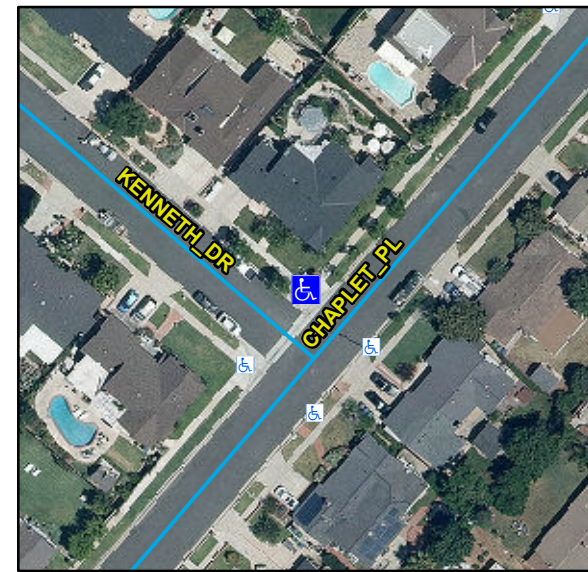
| Compliance | Description | Data | Compliance | Description | Data |
|---|---|---|---|---|---|
| Yes | Ramp Cross Slope LT (%) | 0.5 | No | Ramp Cross Slope RT (%) | 2.3 |

**Remove & Replace Curb Ramp With Two New Directional Ramps or Equivalent.**

**R304.5.3, STD 1115**

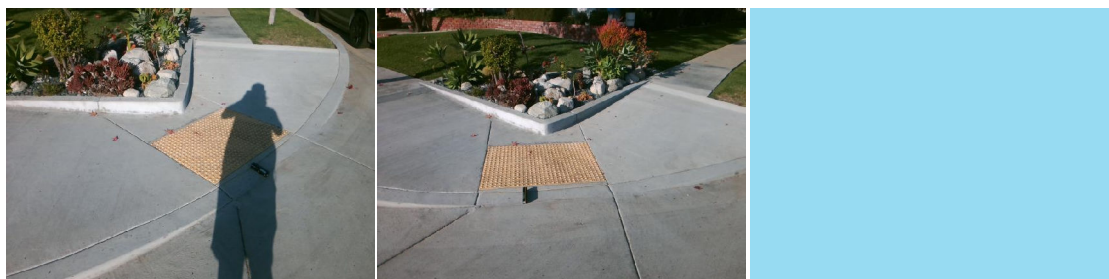
| Compliance | Description | Data | Compliance | Description | Data |
|---|---|---|---|---|---|
| N/A | Ramp Length LT (in) | 100 | N/A | Ramp Length RT (in) | 101 |
| Yes | Ramp Width LT (in) | 92 | Yes | Ramp Width RT (in) | 81 |
| Yes | Ramp Run Slope LT (%) | 5.5 | Yes | Ramp Run Slope RT (%) | 5.1 |
