# Access Compliance Report Public Rights-of-Way (Curb Ramps)

Main Street: CAMEO\_DR Cross Street: DEAN\_ST Location: N

ADA ID: RPAT211108151647 Ramp Type: Type 1 - Perpendicular Diagonal Initial Pass/Fail: Pass Overall Compliance: No Severity Score: 0

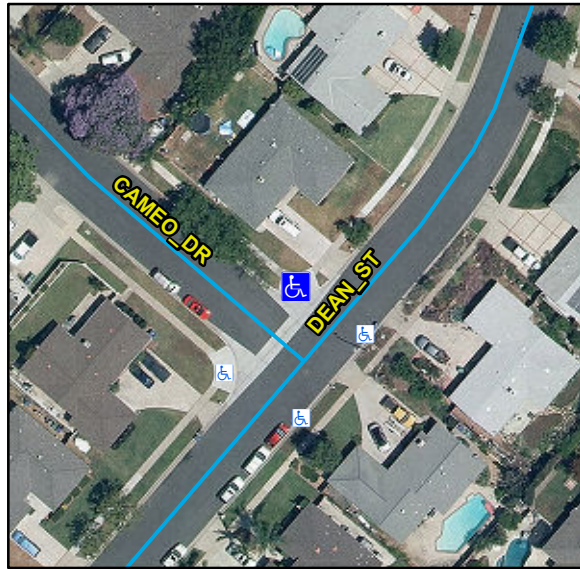
| Compliance | Description | Data | Compliance | Description | Data |
|---|---|---|---|---|---|
| No | Landing Run Slope (%) | 2.3 | N/A | Flare Traversable RT | No |
| Yes | Gutter Ponding | No | No | Curb Slope | 14.9 |

Remove & Replace Curb Ramp With Two New Directional Ramps or Equivalent.
