# Access Compliance Report Public Rights-of-Way (Curb Ramps)

Main Street: TIFFANY\_PL Cross Street: HICKORY\_BRANCH\_RD Location: N

ADA ID: RPAT211109103055 Ramp Type: Type 4 - Parallel Initial Pass/Fail: Fail Overall Compliance: No Severity Score: 2

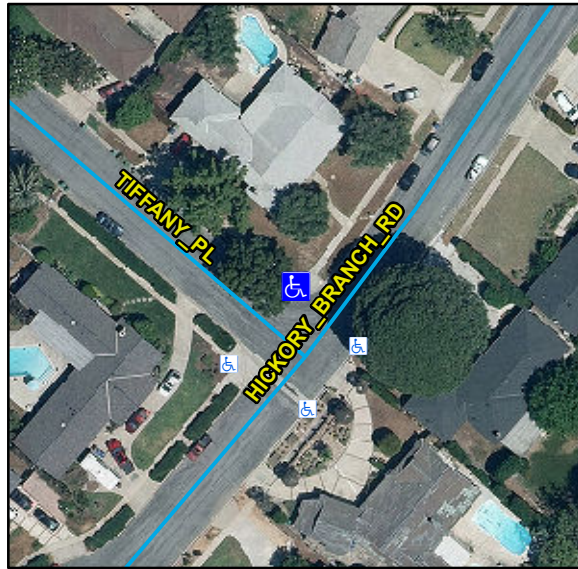
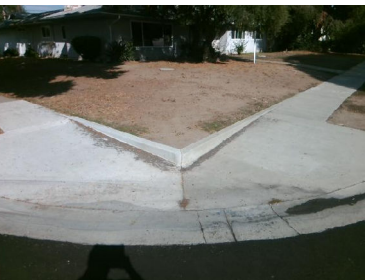
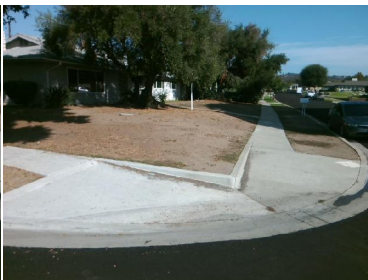
| Compliance | Description | Data | Compliance | Description | Data |
|---|---|---|---|---|---|
| No | Ramp Cross Slope LT (%) | 4.6 | Yes | Ramp Cross Slope RT (%) | 2 |

Remove & Replace Curb Ramp With Two New Directional Ramps or Equivalent.

R304.5.3, STD 1115
