# Access Compliance Report Public Rights-of-Way (Curb Ramps)

Main Street: ALITA\_LN Cross Street: HICKORY\_BRANCH\_RD Location: SE

ADA ID: RPAT211109103922 Ramp Type: Type 4 - Parallel Initial Pass/Fail: Fail Overall Compliance: No Severity Score: 32

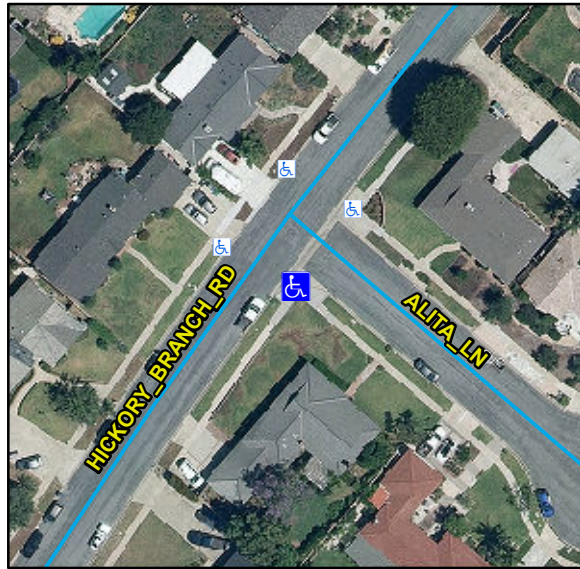
| Compliance | Description | Data | Compliance | Description | Data |
|---|---|---|---|---|---|
| No | Ramp Run Slope LT (%) | 13.9 | Yes | Ramp Run Slope RT (%) | 2 |
| Yes | Ramp Cross Slope LT (%) | 0.8 | No | Ramp Cross Slope RT (%) | 3.5 |

**Remove & Replace Curb Ramp With Two New Directional Ramps or Equivalent.**

**R304.3.2, R304.5.3, STD 1115**
