# Access Compliance Report Public Rights-of-Way (Curb Ramps)

| Main Street: HICKORY_BRANCH_RD | | Cross Street: ALITA_LN | | Location: | E |
| ADA ID: RPAT211109104253 | Ramp Type: Type 4 - Parallel | Initial Pass/Fail: Fail | Overall Compliance: No | Severity Score: | 15 |

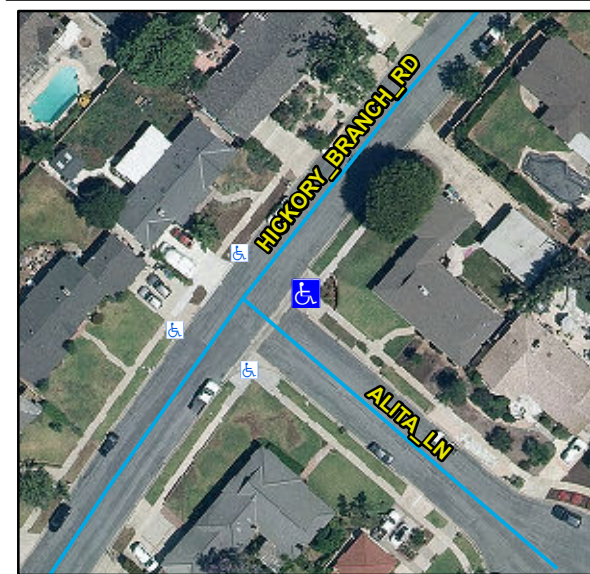
| Compliance | Description | Data | Compliance | Description | Data |
|---|---|---|---|---|---|
| No | Ramp Run Slope LT (%) | 8.5 | Yes | Ramp Run Slope RT (%) | 5.7 |

**Remove & Replace Curb Ramp With Two New Directional Ramps or Equivalent.**

**R304.3.2, STD 1115**

Total Cost: \$ 4000

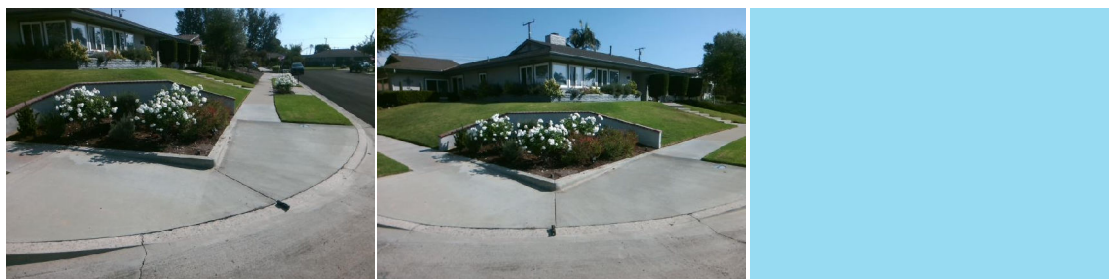
| Compliance | Description | Data | Compliance | Description | Data |
|---|---|---|---|---|---|
| N/A | Ramp Length LT (in) | 110 | N/A | Ramp Length RT (in) | 130 |
| Yes | Ramp Width LT (in) | 86 | Yes | Ramp Width RT (in) | 92 |
| Yes | Ramp Cross Slope LT (%) | 1.9 | Yes | Ramp Cross Slope RT (%) | 1.6 |
