# Access Compliance Report Public Rights-of-Way (Curb Ramps)

| Main Street: HICKORY_BRANCH_RD | | Cross Street: COCKSCROW_LN | | Location: | E |
| ADA ID: RPAT211109104921 | Ramp Type: Type 4 - Parallel | Initial Pass/Fail: Fail | Overall Compliance: No | Severity Score: | 16 |

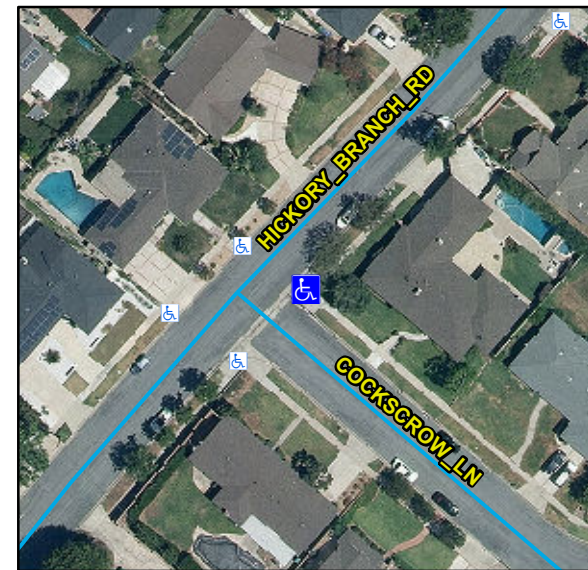
| Compliance | Description | Data | Compliance | Description | Data |
|---|---|---|---|---|---|
| No | Ramp Run Slope LT (%) | 9.2 | Yes | Ramp Run Slope RT (%) | 6.8 |
| Yes | Ramp Cross Slope LT (%) | 0.5 | No | Ramp Cross Slope RT (%) | 4 |

**Remove & Replace Curb Ramp With Two New Directional Ramps or Equivalent.**

**R304.3.2, R304.5.3, STD 1115**

Total Cost: \$ 4000
