# Access Compliance Report Public Rights-of-Way (Curb Ramps)

| Main Street: RAINBOW_DR | | Cross Street: HICKORY_BRANCH_RD | | Location: | SE |
| ADA ID: RPAT211109105512 | Ramp Type: Type 4 - Parallel | Initial Pass/Fail: Fail | Overall Compliance: No | Severity Score: | 2 |

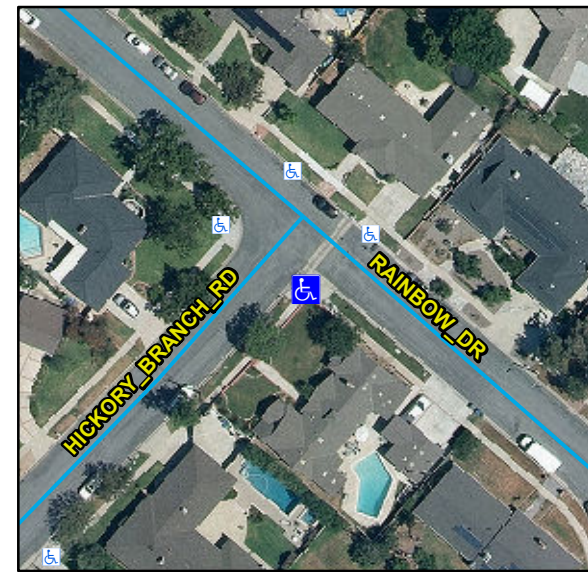
| Compliance | Description | Data | Compliance | Description | Data |
|---|---|---|---|---|---|
| No | Ramp Cross Slope LT (%) | 2.9 | No | Ramp Cross Slope RT (%) | 2.2 |

**Remove & Replace Curb Ramp With Two New Directional Ramps or Equivalent.**

**R304.5.3, STD 1115**

Total Cost: \$ 4000
