# Access Compliance Report Public Rights-of-Way (Curb Ramps)

Main Street: DEAN\_ST Cross Street: GARLAND\_AVE Location: NW

ADA ID: RPAT211109133342 Ramp Type: Type 1 - Perpendicular Diagonal Initial Pass/Fail: Pass Overall Compliance: No Severity Score: 5

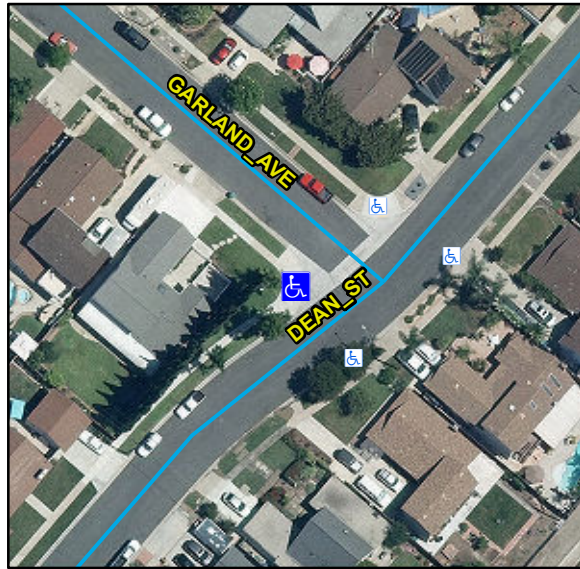
| Compliance | Description | Data | Compliance | Description | Data |
|---|---|---|---|---|---|
| Yes | Gutter Ponding | No | No | Curb Slope | 5.1 |
| No | Gutter Run Slope (%) | 5.5 | | Road Cross Slope (%) | 1.9 |

**Remove & Replace Curb Ramp With Two New Directional Ramps or Equivalent. Remove & Replace Gutter.**

**R304.2.2, R304.2.1, R304.5.4, STD 1115**
