# Access Compliance Report Public Rights-of-Way (Curb Ramps)

Main Street: GARLAND\_AVE Cross Street: DEAN\_ST Location: N

ADA ID: RPAT211109133744 Ramp Type: Type 1 - Perpendicular Diagonal Initial Pass/Fail: Fail Overall Compliance: No Severity Score: 16

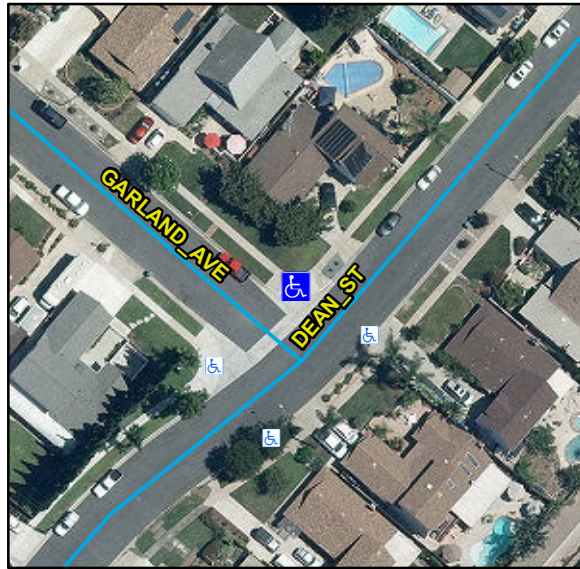
| Compliance | Description | Data | Compliance | Description | Data |
|---|---|---|---|---|---|
| No | Ramp Run Slope (%) | 8.4 | N/A | Flare Slope LT (%) | N/A |

Remove & Replace Curb Ramp With Two New Directional Ramps or Equivalent.

R304.2.2, STD 1115
