# Access Compliance Report Public Rights-of-Way (Curb Ramps)

Main Street: WOODLAND\_DR Cross Street: MELVIN\_WY Location: W

ADA ID: RPAT211109135212 Ramp Type: Type 1 - Perpendicular Diagonal Initial Pass/Fail: Pass Overall Compliance: No Severity Score: 5

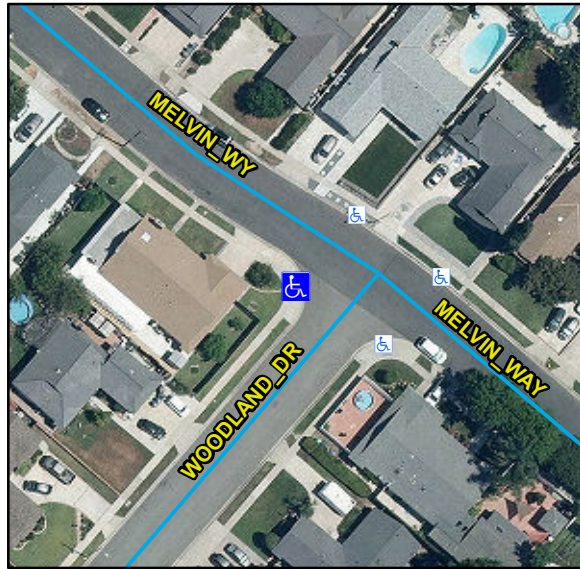
| Compliance | Description | Data | Compliance | Description | Data |
|---|---|---|---|---|---|
| Yes | Gutter Ponding | No | No | Curb Slope | 9.7 |
| No | Gutter Run Slope (%) | 6 | | Road Cross Slope (%) | 4.6 |

Remove & Replace Curb Ramp With Two New Directional Ramps or Equivalent. Remove & Replace Gutter.
