# Access Compliance Report Public Rights-of-Way (Curb Ramps)

| Main Street: BLUEBERRY_WAY | | Cross Street: DEAN_ST | | Location: | N |
| ADA ID: RPAT211109141510 | Ramp Type:Type 1 - Perpendicular Diagonal Initial Pass/Fail: Fail | | Overall Compliance: No | Severity Score: | 15 |

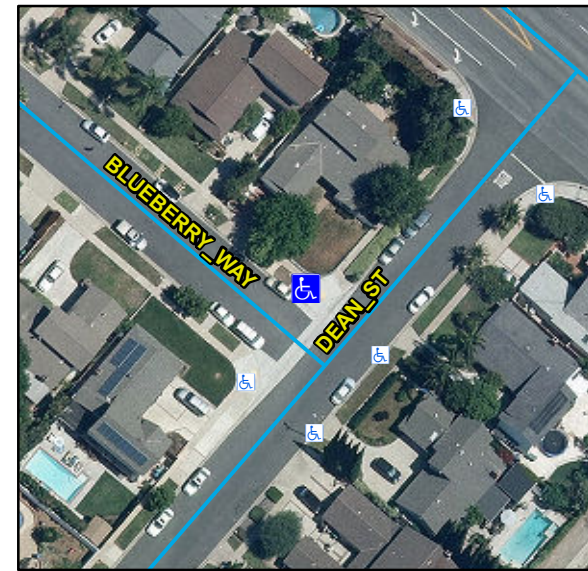
| Compliance | Description | Data | Compliance | Description | Data |
|---|---|---|---|---|---|
| No | Ramp Run Slope (%) | 8.6 | N/A | Flare Slope LT (%) | N/A |
| N/A | Gutter Ponding | N/A | No | Curb Slope | 7.2 |

Possible Solutions:

**Remove & Replace Curb Ramp With Two New Directional Ramps or Equivalent.**

**R304.2.2, STD 1115**
