# Access Compliance Report Public Rights-of-Way (Curb Ramps)

Main Street: HOLT\_AVE Cross Street: THEODORA\_DR Location: SW

ADA ID: RPAT211110132434 Ramp Type: Type 4 - Parallel Initial Pass/Fail: Fail Overall Compliance: No Severity Score: 30

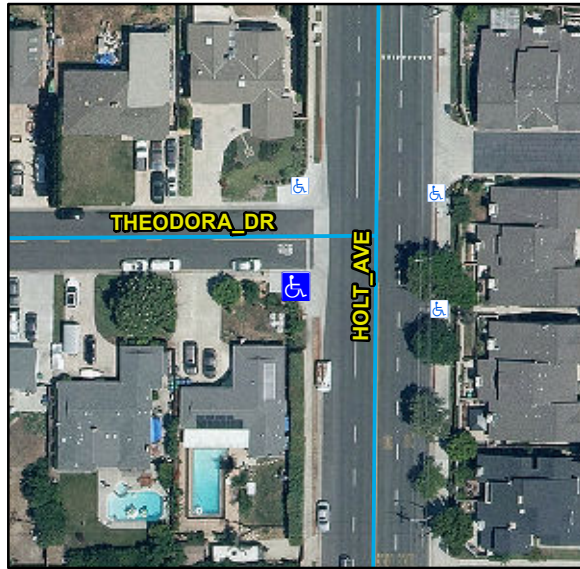
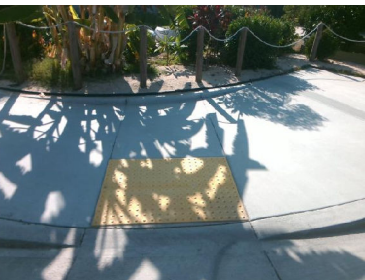
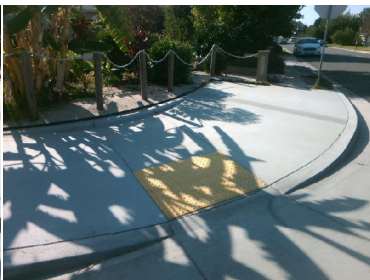
| Compliance | Description | Data | Compliance | Description | Data |
|---|---|---|---|---|---|
| No | Ramp Cross Slope LT (%) | 7.7 | No | Ramp Cross Slope RT (%) | 5.1 |

**Remove & Replace Curb Ramp With Two New Directional Ramps or Equivalent.**

**R304.5.3, STD 1115**
