# Access Compliance Report Public Rights-of-Way (Curb Ramps)

Main Street: PROSPECT\_AVE Cross Street: BIGELOW\_PKWY Location: NE

ADA ID: RPAT211110145546 Ramp Type: Type 4 - Parallel Initial Pass/Fail: Fail Overall Compliance: No Severity Score: 16

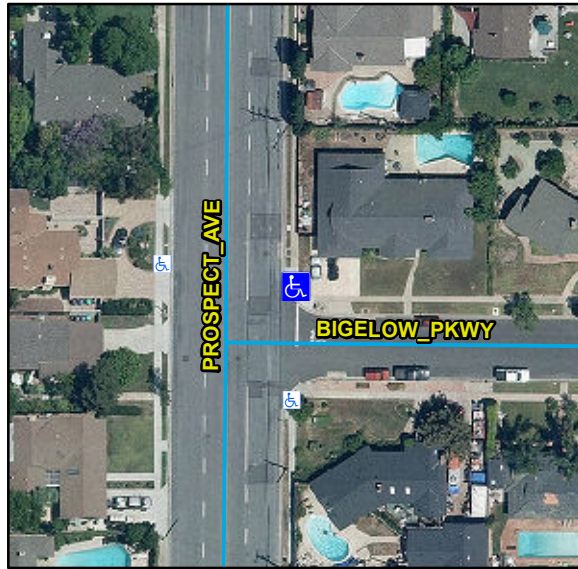
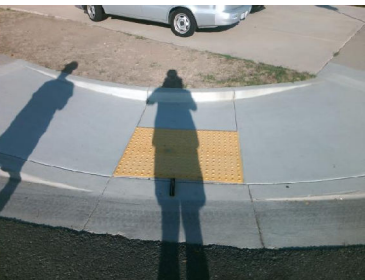
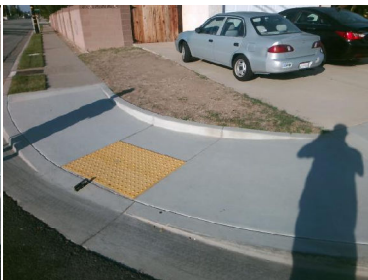
| Compliance | Description | Data | Compliance | Description | Data |
|---|---|---|---|---|---|
| No | Ramp Run Slope LT (%) | 8.4 | Yes | Ramp Run Slope RT (%) | 6.1 |
| Yes | Ramp Cross Slope LT (%) | 1.4 | No | Ramp Cross Slope RT (%) | 3.2 |

Remove & Replace Curb Ramp With Two New Directional Ramps or Equivalent.
