# Access Compliance Report Public Rights-of-Way (Curb Ramps)

Main Street: FAIRHAVEN\_AVE Cross Street: S\_OAKWOOD\_ST Location: NW

ADA ID: RPAT211111103038 Ramp Type: Type 4 - Parallel Initial Pass/Fail: Fail Overall Compliance: No Severity Score: 2

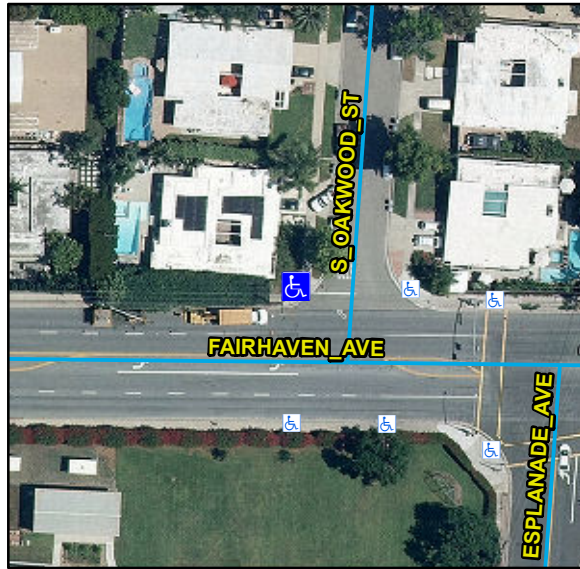
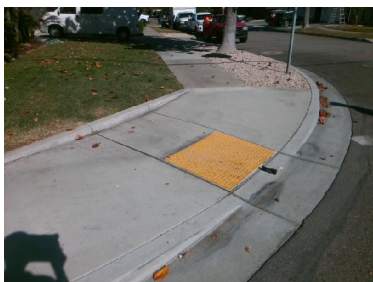
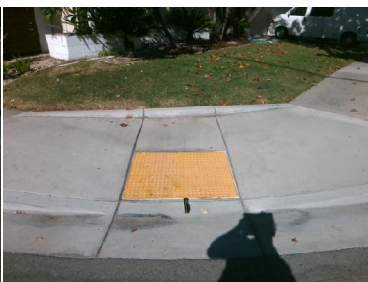
| Compliance | Description | Data | Compliance | Description | Data |
|---|---|---|---|---|---|
| No | Ramp Cross Slope LT (%) | 2.1 | Yes | Ramp Cross Slope RT (%) | 1.2 |

**Remove & Replace Curb Ramp With Two New Directional Ramps or Equivalent.**

**R304.5.3, STD 1115**
