# Access Compliance Report Public Rights-of-Way (Curb Ramps)

| Main Street: ESPLANADE_AVE | | Cross Street: FAIRHAVEN_AVE | | Location: | SW |
| ADA ID: RPAT211111105132 | | Ramp Type: Type 1 - Perpendicular Diagonal Initial Pass/Fail: Fail | | Overall Compliance: No | Severity Score: 16 |

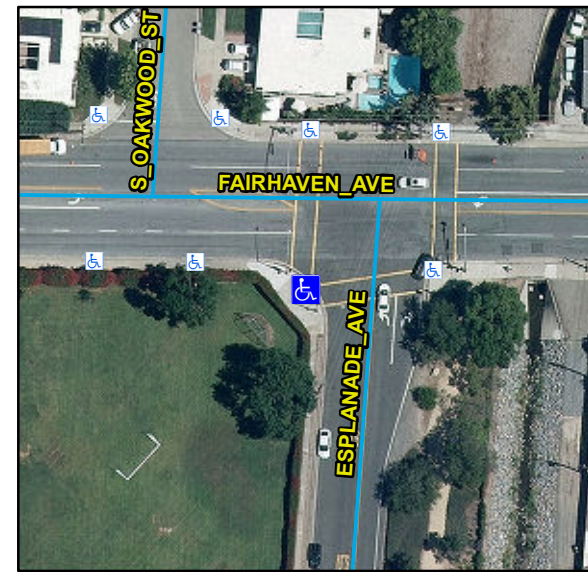
| Compliance | Description | Data | Compliance | Description | Data |
|---|---|---|---|---|---|
| No | Ramp Run Slope (%) | 8.7 | N/A | Flare Slope LT (%) | N/A |

**Remove & Replace Curb Ramp With Two New Directional Ramps or Equivalent.**

**R204.3, R304.2.2, STD 1115**

Total Cost: \$ 6160
