# Access Compliance Report Public Rights-of-Way (Curb Ramps)

Main Street: FAIRHAVEN\_AVE Cross Street: ESPLANADE\_ST Location: NW

ADA ID: RPAT211111105811 Ramp Type: Type 4 - Parallel Initial Pass/Fail: Fail Overall Compliance: No Severity Score: 16

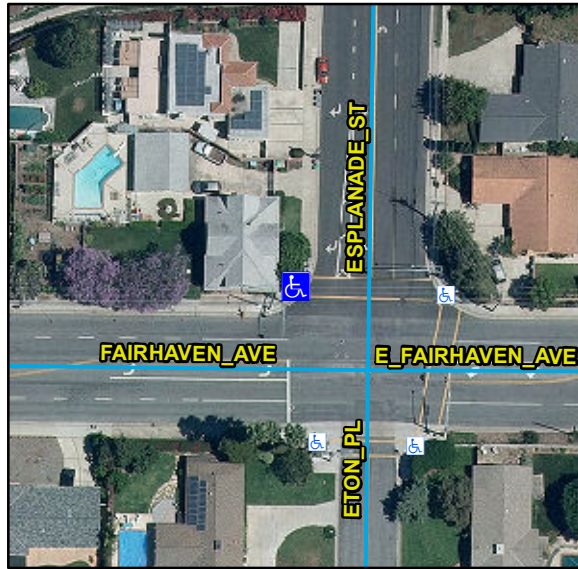
| Compliance | Description | Data | Compliance | Description | Data |
|---|---|---|---|---|---|
| Yes | Ramp Run Slope LT (%) | 5.7 | No | Ramp Run Slope RT (%) | 11.6 |
| No | Ramp Cross Slope LT (%) | 2.4 | Yes | Ramp Cross Slope RT (%) | 0.5 |

Remove & Replace Curb Ramp With Two New Directional Ramps or Equivalent.

R304.5.3, R304.3.2, STD 1115
