# Access Compliance Report Public Rights-of-Way (Curb Ramps)

Main Street: SANBERT\_ST Cross Street: LYMAN\_AVE Location: NE

ADA ID: RPAT211112095204 Ramp Type: Type 1 - Perpendicular Diagonal Initial Pass/Fail: Pass Overall Compliance: No Severity Score: 7

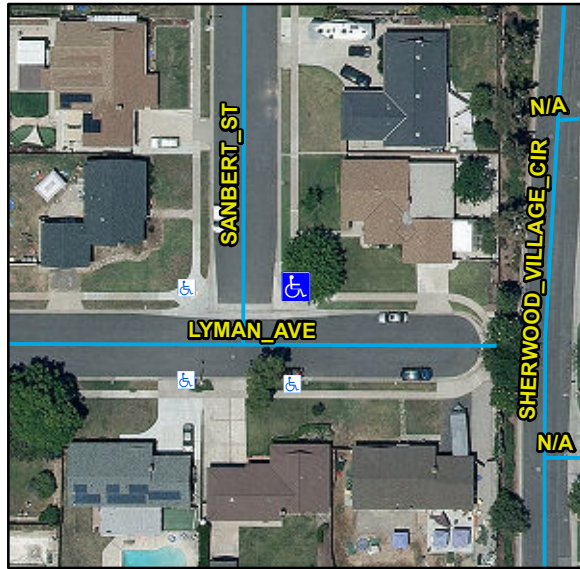
| Compliance | Description | Data | Compliance | Description | Data |
|---|---|---|---|---|---|
| No | Ramp Cross Slope (%) | 2.6 | N/A | Flare Traversable LT | No |
| No | Landing Cross Slope (%) | 2.2 | Yes | DWS Provided | Yes |
| No | Gutter Run Slope (%) | 6.3 | | Road Cross Slope (%) | 2.6 |
| No | Gutter Cross Slope (%) | 4.1 | | | |

Remove & Replace Curb Ramp With Two New Directional Ramps or Equivalent. Remove & Replace Gutter.
