# Access Compliance Report Public Rights-of-Way (Curb Ramps)

Main Street: LYMAN\_AVE Cross Street: KERMATH\_ST Location: SE

ADA ID: RPAT211112111418 Ramp Type: Type 1 - Perpendicular Diagonal Initial Pass/Fail: Pass Overall Compliance: No Severity Score: 0

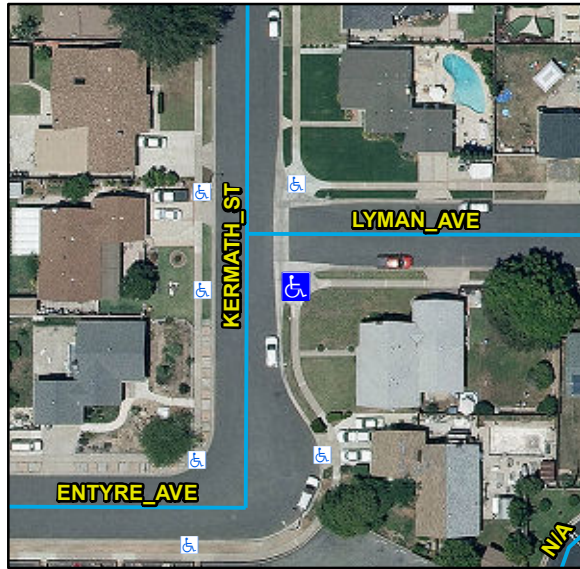
| Compliance | Description | Data | Compliance | Description | Data |
|---|---|---|---|---|---|
| Yes | Gutter Ponding | No | No | Curb Slope | 16 |

Remove & Replace Curb Ramp With Two New Directional Ramps or Equivalent.

R304.2.2, R304.2.1, STD 1115
