# Access Compliance Report Public Rights-of-Way (Curb Ramps)

Main Street: KERMATH\_ST Cross Street: LYMAN\_AVE Location: NE

ADA ID: RPAT211112111721 Ramp Type: Type 1 - Perpendicular Diagonal Initial Pass/Fail: Pass Overall Compliance: No Severity Score: 2

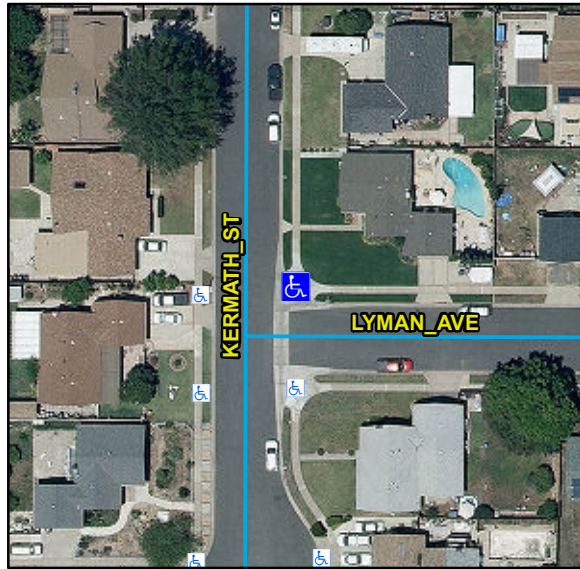
| Compliance | Description | Data | Compliance | Description | Data |
|---|---|---|---|---|---|
| Yes | Gutter Ponding | No | No | Curb Slope | 6.6 |

Possible Solutions:

Remove & Replace Curb Slope.

R304.2.2, STD 1115

\$ 252

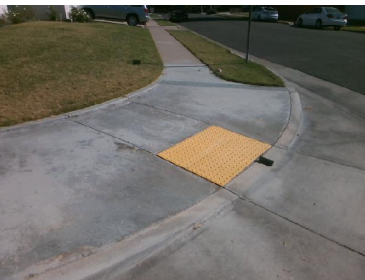
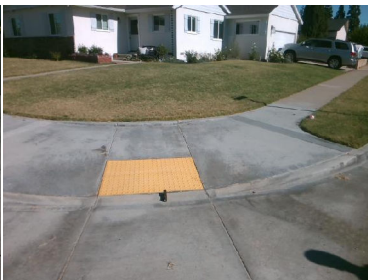
| Compliance | Description | Data | Compliance | Description | Data |
|---|---|---|---|---|---|
| Yes | Overall Surface Condition: Acceptable | | Yes | Perp Joint Present | Yes |
