# Access Compliance Report Public Rights-of-Way (Curb Ramps)

Main Street: MCCORMACK\_LN Cross Street: ENTYRE\_AVE Location: NE

ADA ID: RPAT211112112247 Ramp Type: Type 1 - Perpendicular Diagonal Initial Pass/Fail: Fail Overall Compliance: No Severity Score: 15

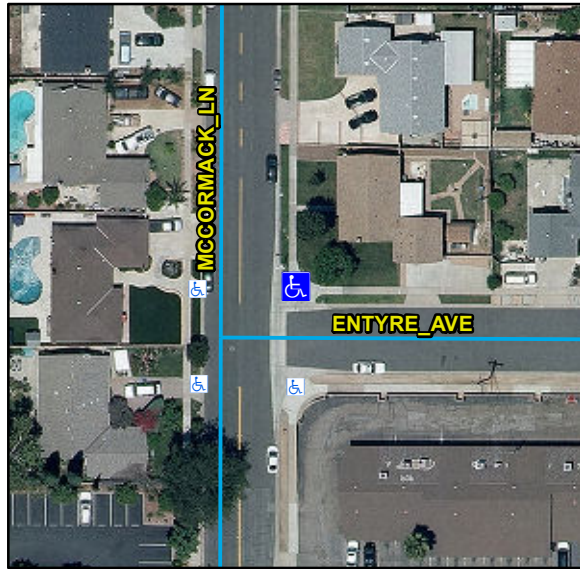
| Compliance | Description | Data | Compliance | Description | Data |
|---|---|---|---|---|---|
| No | Ramp Run Slope (%) | 8.4 | N/A | Flare Slope LT (%) | N/A |

Remove & Replace Curb Ramp With Two New Directional Ramps or Equivalent.

R304.2.2, STD 1115

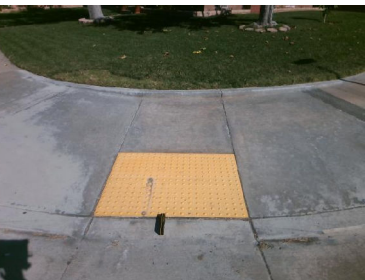
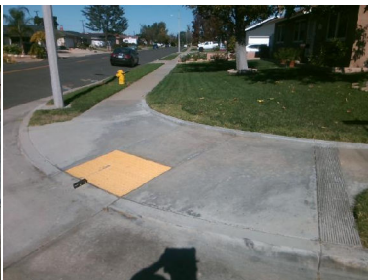
| Compliance | Description | Data | Compliance | Description | Data |
|---|---|---|---|---|---|
| Yes | Overall Surface Condition: Acceptable | | Yes | Perp Joint Present | Yes |
