# Access Compliance Report Public Rights-of-Way (Curb Ramps)

Main Street: LUTE\_AVE Cross Street: CEDARLAWN\_DR Location: SE

ADA ID: RPAT211112152443 Ramp Type: Type 1 - Perpendicular Diagonal Initial Pass/Fail: Pass Overall Compliance: No Severity Score: 0

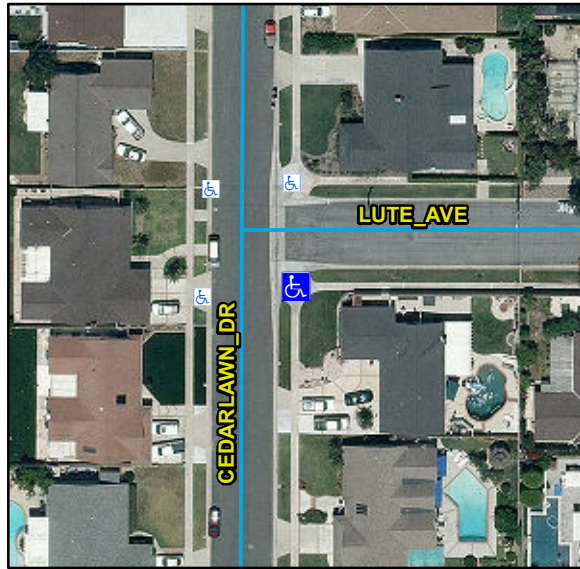
| Compliance | Description | Data | Compliance | Description | Data |
|---|---|---|---|---|---|
| Yes | Gutter Ponding | No | No | Curb Slope | 11.4 |

Remove & Replace Curb Ramp With Two New Directional Ramps or Equivalent.

R304.2.2, R304.2.1, STD 1115
