# Access Compliance Report Public Rights-of-Way (Curb Ramps)

Main Street: CEDARLAWN\_DR Cross Street: LUTE\_AVE Location: NE

ADA ID: RPAT21112152800 Ramp Type: Type 1 - Perpendicular Diagonal Initial Pass/Fail: Pass Overall Compliance: No Severity Score: 2

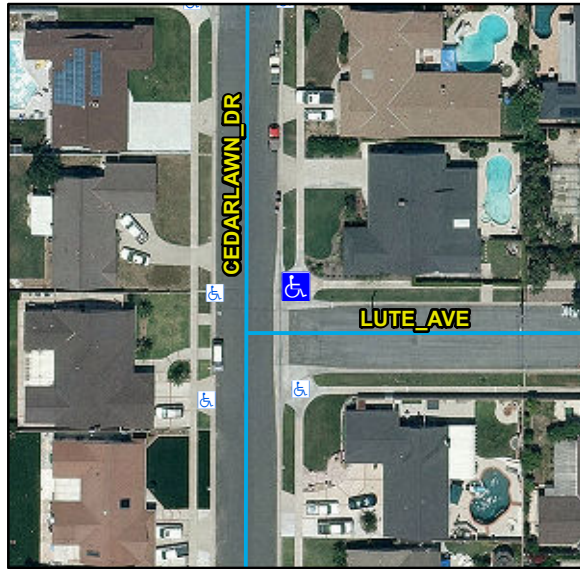
| Compliance | Description | Data | Compliance | Description | Data |
|---|---|---|---|---|---|
| Yes | Gutter Ponding | No | No | Curb Slope | 7 |

Remove & Replace Curb Slope.

R304.2.2, STD 1115
