# Access Compliance Report Public Rights-of-Way (Curb Ramps)

| Main Street: OLD_RANCH_RD | | Cross Street: FAIRMONT_BLV | | Location: | NW |
| ADA ID: RPAT211115111027 | Ramp Type: Type 4 - Parallel | Initial Pass/Fail: Fail | Overall Compliance: No | Severity Score: | 16 |

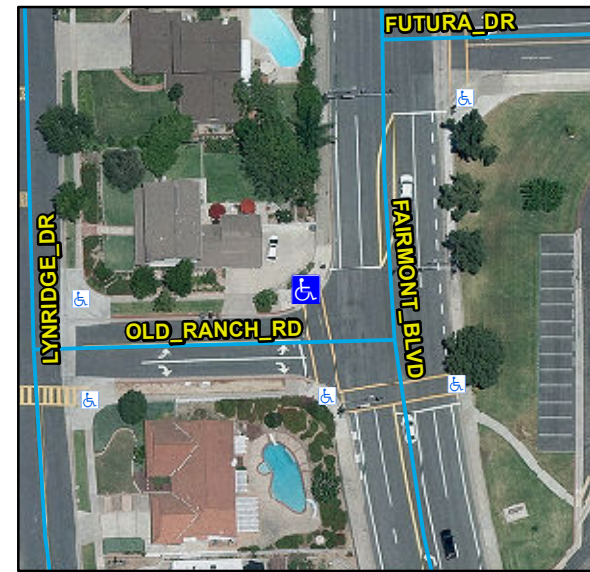
| Compliance | Description | Data | Compliance | Description | Data |
|---|---|---|---|---|---|
| Yes | Ramp Run Slope LT (%) | 1.2 | No | Ramp Run Slope RT (%) | 11.3 |
| No | Ramp Cross Slope LT (%) | 2.6 | Yes | Ramp Cross Slope RT (%) | 0.7 |

Possible Solutions:

**Remove & Replace Curb Ramp With Two New Directional Ramps or Equivalent.**

**R304.5.3, R304.3.2, STD 1115**

Total Cost: \$ 4000

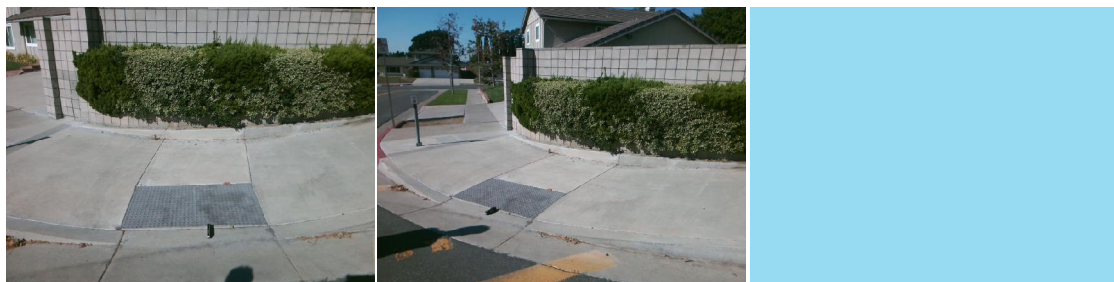
| Compliance | Description | Data | Compliance | Description | Data |
|---|---|---|---|---|---|
| N/A | Ramp Length LT (in) | 90 | N/A | Ramp Length RT (in) | 112 |
| Yes | Ramp Width LT (in) | 113 | Yes | Ramp Width RT (in) | 104 |
