# Access Compliance Report Public Rights-of-Way (Curb Ramps)

| Main Street: FUTURA_DR | | Cross Street: FAIRMONT_BLVD | | Location: | SE |
| ADA ID: RPAT211115111552 | Ramp Type:Type 1 - Perpendicular Diagonal Initial Pass/Fail: Fail | | Overall Compliance: No | Severity Score: | 34 |

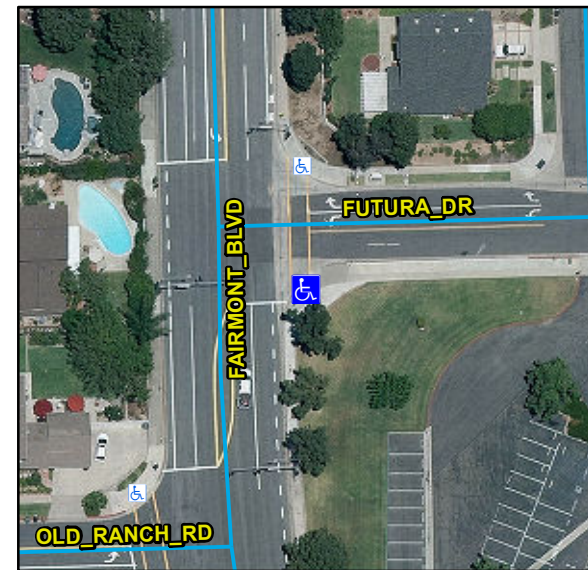
| Compliance | Description | Data | Compliance | Description | Data |
|---|---|---|---|---|---|
| No | Ramp Width (in) | 47 | | | N/A |
| No | Ramp Run Slope (%) | 12.6 | N/A | Flare Slope LT (%) | N/A |

**Remove & Replace Curb Ramp With Two New Directional Ramps or Equivalent.**

**R304.5.1, R304.2.2, STD 1115**
