# Access Compliance Report Public Rights-of-Way (Curb Ramps)

Main Street: WEST\_KNOLL\_DR Cross Street: WENDOVER\_RD Location: NE

ADA ID: RPAT211115133841 Ramp Type: Type 1 - Perpendicular Diagonal Initial Pass/Fail: Pass Overall Compliance: No Severity Score: 0

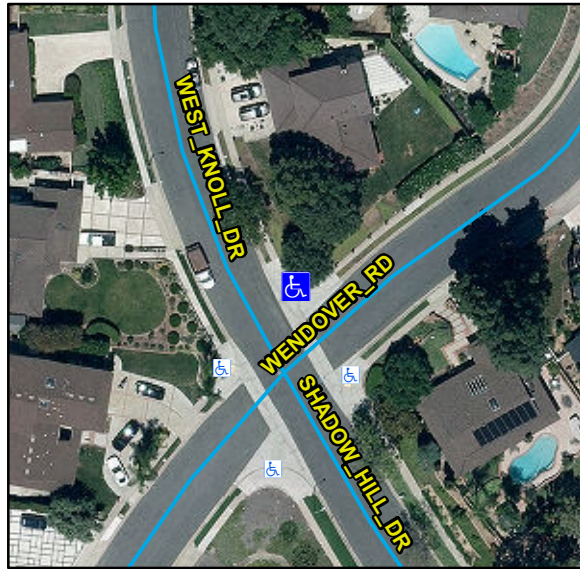
| Compliance | Description | Data | Compliance | Description | Data |
|---|---|---|---|---|---|
| No | Landing Run Slope (%) | 2.1 | N/A | Flare Traversable RT | No |
| Yes | Gutter Ponding | No | No | Curb Slope | 13.7 |

Remove & Replace Curb Ramp With Two New Directional Ramps or Equivalent.
