# Access Compliance Report Public Rights-of-Way (Curb Ramps)

| Main Street: LARKRIDGE_DR | | Cross Street: LARKRIDGE_DR | | Location: | SE |
| ADA ID: RPAT211115142234 | Ramp Type:Type 1 - Perpendicular | Initial Pass/Fail: Fail | Overall Compliance: No | Severity Score: | 19 |

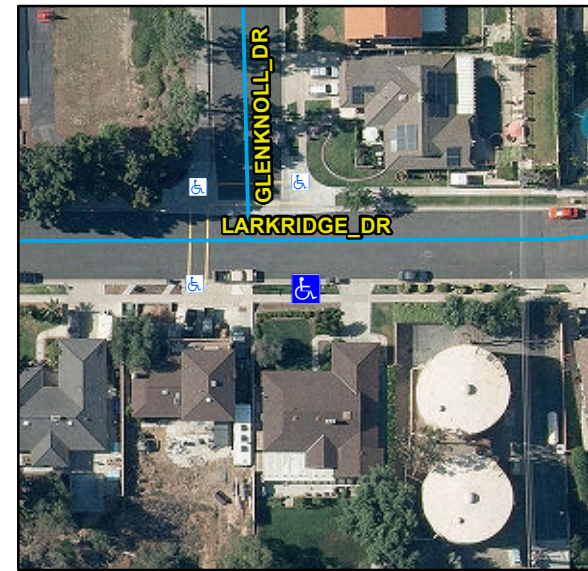
R204.3, R304.5.1, R304.2.2, STD 1115

| Compliance | Description | Data | Compliance | Description | Data |
|---|---|---|---|---|---|
| No | Ramp Width (in) | 40 | | | N/A |
| No | Ramp Run Slope (%) | 9.1 | N/A | Flare Slope LT (%) | N/A |

Possible Solutions:

Remove & Replace Entire Ramp.

Total Cost: \$ 3080
