# Access Compliance Report Public Rights-of-Way (Curb Ramps)

| Main Street: FAIRLYNN_BLV | | Cross Street: OAKVALE_DR | | Location: | NW |
| ADA ID: RPAT211115144429 | Ramp Type: Blended Transition 1 | Initial Pass/Fail: Fail | Overall Compliance: No | Severity Score: | 15 |

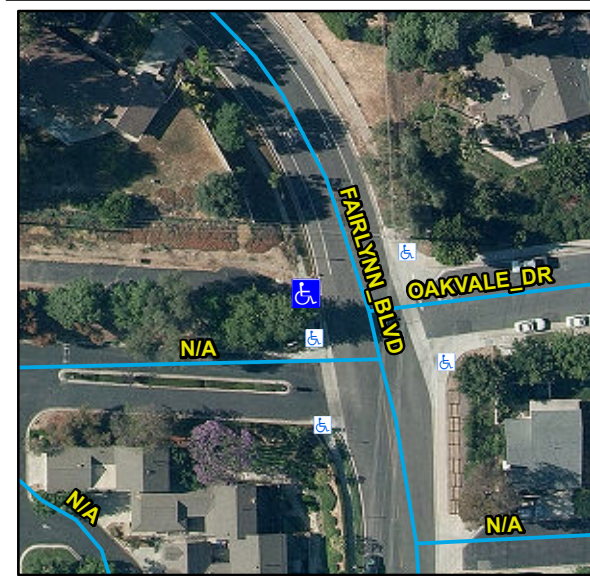
| Compliance | Description | Data | Compliance | Description | Data |
|---|---|---|---|---|---|
| No | Ramp Cross Slope (%) | 6.7 | N/A | Flare Traversable RT | N/A |
| N/A | Gutter Ponding | N/A | No | Curb Slope | 9.1 |

**Remove & Replace Curb Ramp With Two New Directional Ramps or Equivalent.**

**R304.2.2, R304.5.3, STD 1115**
