# Access Compliance Report Public Rights-of-Way (Curb Ramps)

Main Street: WOODGATE\_DR Cross Street: CEDARBEND\_DR Location: NW

ADA ID: RPAT211115145707 Ramp Type: Type 1 - Perpendicular Diagonal Initial Pass/Fail: Fail Overall Compliance: No Severity Score: 0

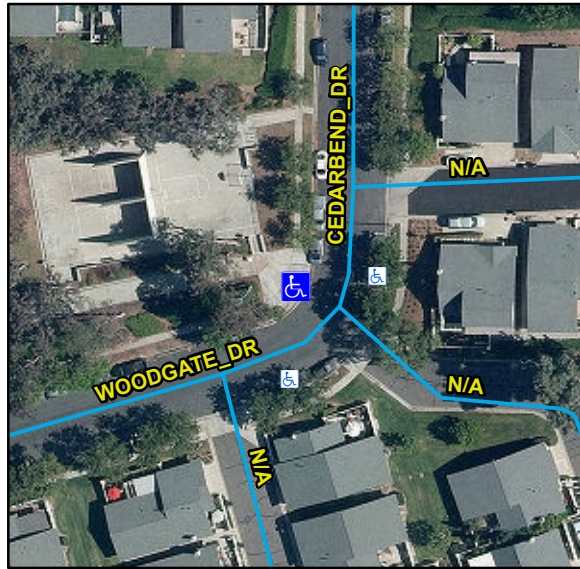
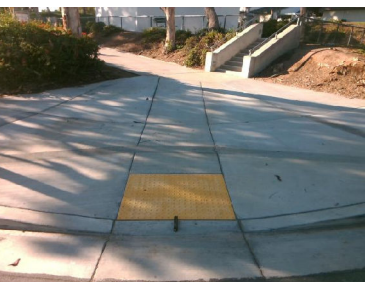
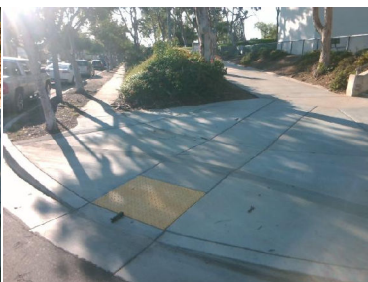
| Compliance | Description | Data | Compliance | Description | Data |
|---|---|---|---|---|---|
| N/A | Gutter Ponding | N/A | No | Curb Slope | 6.8 |

Remove & Replace Curb Ramp With Two New Directional Ramps or Equivalent.

R304.2.2, STD 1115
