# Access Compliance Report Public Rights-of-Way (Curb Ramps)

| Main Street: CAMPUS_DR | | Cross Street: STONYBROOK_DR | | Location: | NE |
| ADA ID: RPAT211117114409 | Ramp Type: Type 4 - Parallel | Initial Pass/Fail: Pass | Overall Compliance: No | Severity Score: | 0 |

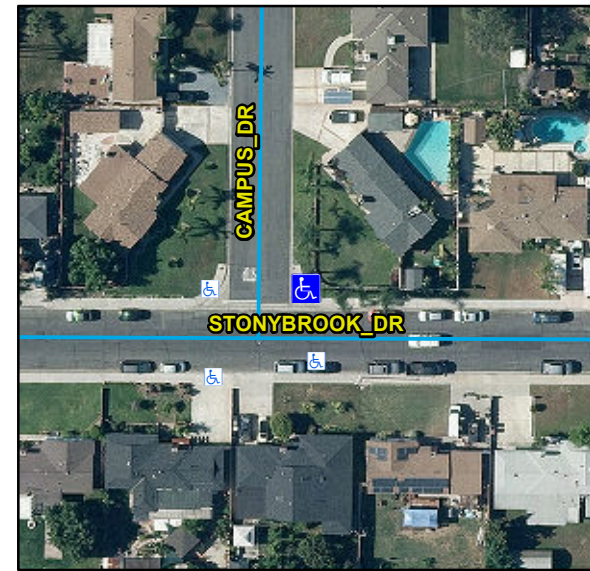
**R304.2.2-Perp, R304.3.2-Para, STD 1115**

| Compliance | Description | Data | Compliance | Description | Data |
|---|---|---|---|---|---|
| No | Landing Run Slope (%) | 2.7 | Yes | DWS Full Width | Yes |

**Remove & Replace Landing.**
