# Access Compliance Report Public Rights-of-Way (Curb Ramps)

Main Street: STONYBROOK\_DR Cross Street: CAMPUS\_DR Location: NW

ADA ID: RPAT211117114922 Ramp Type: Type 4 - Parallel Initial Pass/Fail: Fail Overall Compliance: No Severity Score: 2

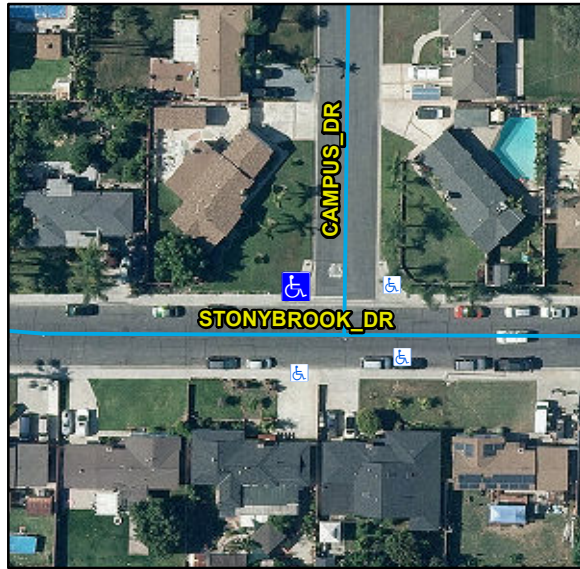
| Compliance | Description | Data | Compliance | Description | Data |
|---|---|---|---|---|---|
| Yes | Ramp Cross Slope LT (%) | 0.5 | No | Ramp Cross Slope RT (%) | 2.1 |

Remove & Replace Curb Ramp With Two New Directional Ramps or Equivalent.

R304.5.3, STD 1115

Total Cost: \$ 4000
