# Access Compliance Report Public Rights-of-Way (Curb Ramps)

Main Street: GREENWICH\_LN Cross Street: STONYBROOK\_DR Location: NE

ADA ID: RPAT211117115321 Ramp Type: Type 4 - Parallel Initial Pass/Fail: Pass Overall Compliance: No Severity Score: 0

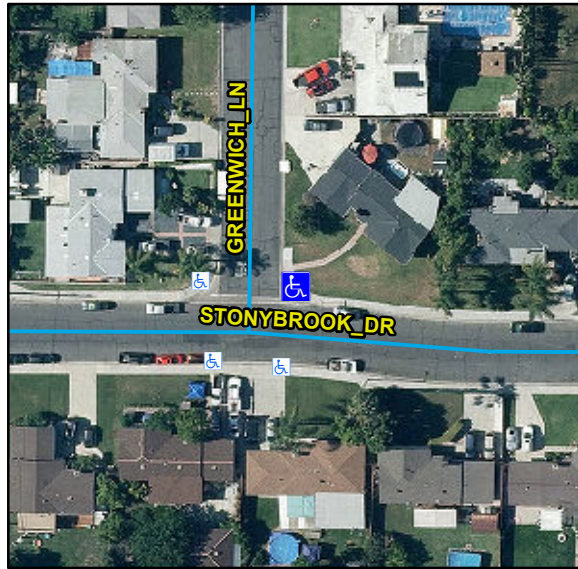
| Compliance | Description | Data | Compliance | Description | Data |
|---|---|---|---|---|---|
| No | Gutter Cross Slope (%) | 2.2 | Yes | Perpendicular Joint Present | Yes |

Remove & Replace Gutter.

R304.5.3, STD 1115
