# Access Compliance Report Public Rights-of-Way (Curb Ramps)

Main Street: STONYBROOK\_DR Cross Street: HILLVIEW\_RD Location: NW

ADA ID: RPAT211117123246 Ramp Type: Type 4 - Parallel Initial Pass/Fail: Fail Overall Compliance: No Severity Score: 2

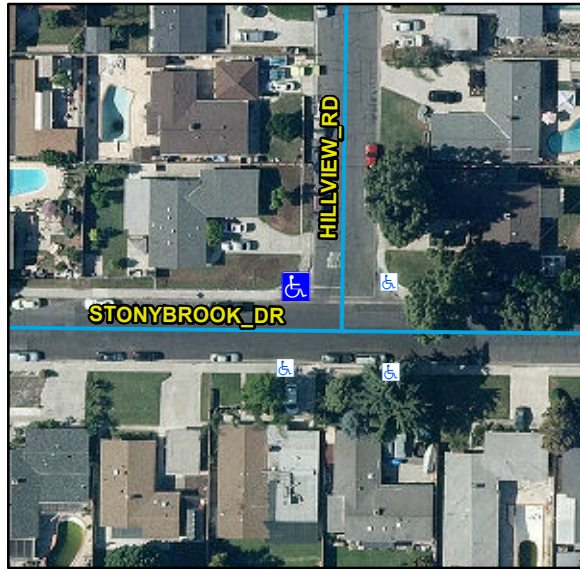
| Compliance | Description | Data | Compliance | Description | Data |
|---|---|---|---|---|---|
| No | Ramp Cross Slope LT (%) | 2.2 | Yes | Ramp Cross Slope RT (%) | 0.4 |

**Remove & Replace Curb Ramp With Two New Directional Ramps or Equivalent.**

**R304.5.3, STD 1115**
