# Access Compliance Report Public Rights-of-Way (Curb Ramps)

Main Street: MESSERSMITH\_AVE Cross Street: GREENWICH\_LN Location: SE

ADA ID: RPAT211118095238 Ramp Type: Type 1 - Perpendicular Diagonal Initial Pass/Fail: Pass Overall Compliance: No Severity Score: 20

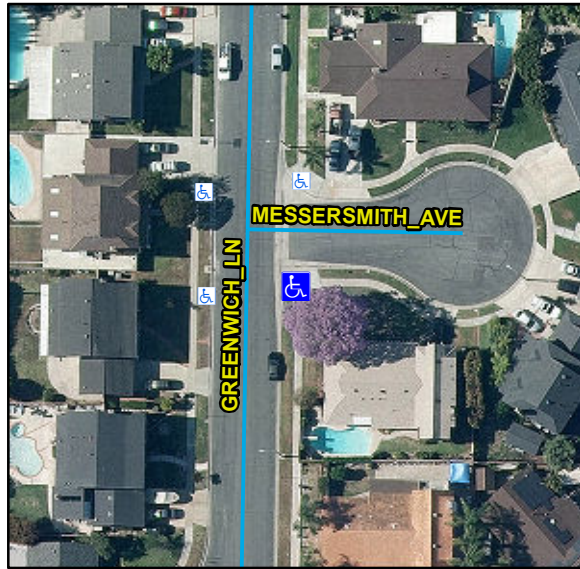
| Compliance | Description | Data | Compliance | Description | Data |
|---|---|---|---|---|---|
| N/A | Ramp Length (in) | 116 | N/A | Flare Type LT | |
| Yes | Ramp Width (in) | 50 | | | Sloped |
| Yes | Ramp Run Slope (%) | 6.6 | N/A | Flare Slope LT (%) | 4.4 |
| Yes | Ramp Cross Slope (%) | 0.3 | N/A | Flare Traversable LT | No |
| No | Landing Width (in) | N/A | N/A | Flare Slope RT (%) | 3.6 |
| No | Landing Run Slope (%) | N/A | N/A | Flare Traversable RT | No |
| No | Landing Cross Slope (%) | N/A | No | DWS Provided | No |
| Yes | Gutter Ponding | No | No | Curb Slope | 13.1 |

Remove & Replace Curb Ramp With Two New Directional Ramps or Equivalent.

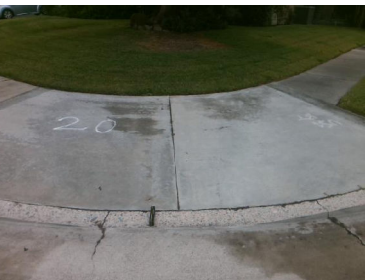
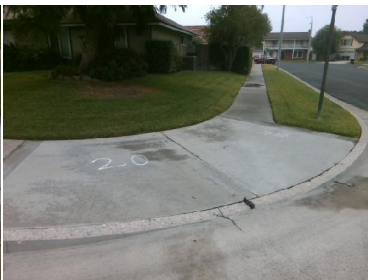
| Compliance | Description | Data | Compliance | Description | Data |
|---|---|---|---|---|---|
| Yes | Overall Surface Condition: Acceptable | | No | Perp Joint Present | No |
