# Access Compliance Report Public Rights-of-Way (Curb Ramps)

Main Street: GREENWICH\_LN Cross Street: MESSERSMITH\_AVE Location: NE

ADA ID: RPAT211118095703 Ramp Type: Type 1 - Perpendicular Diagonal Initial Pass/Fail: Fail Overall Compliance: No Severity Score: 2

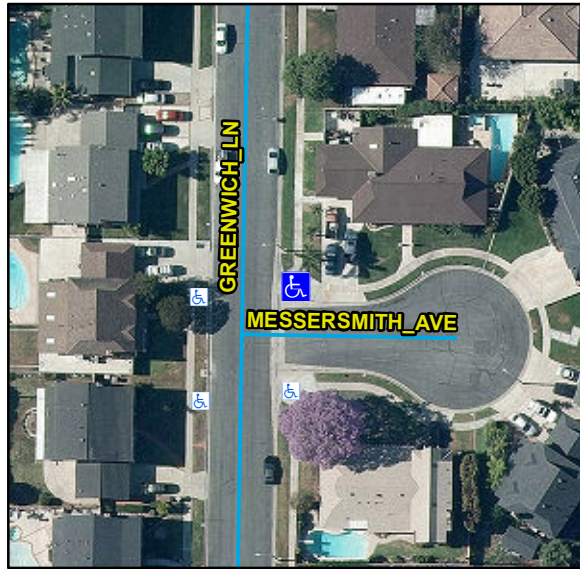
| Compliance | Description | Data | Compliance | Description | Data |
|---|---|---|---|---|---|
| No | Ramp Cross Slope (%) | 2.1 | N/A | Flare Traversable LT | N/A |

Remove & Replace Curb Ramp With Two New Directional Ramps or Equivalent.
