# Access Compliance Report Public Rights-of-Way (Curb Ramps)

Main Street: ANTIGUA\_ST Cross Street: BIENVILLE\_AVE Location: SW

ADA ID: RPAT211118105806 Ramp Type: Type 4 - Parallel Initial Pass/Fail: Pass Overall Compliance: No Severity Score: 0

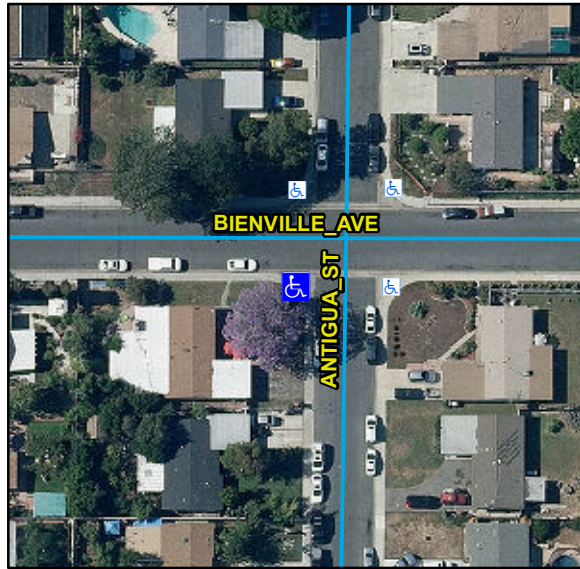
| Compliance | Description | Data | Compliance | Description | Data |
|---|---|---|---|---|---|
| No | Gutter Cross Slope (%) | 2.6 | Yes | Perpendicular Joint Present | Yes |

Remove & Replace Gutter.
