# Access Compliance Report Public Rights-of-Way (Curb Ramps)

Main Street: PERDIDO\_ST Cross Street: BIENVILLE\_AVE Location: SW

ADA ID: RPAT211118110237 Ramp Type: Type 4 - Parallel Initial Pass/Fail: Pass Overall Compliance: No Severity Score: 0

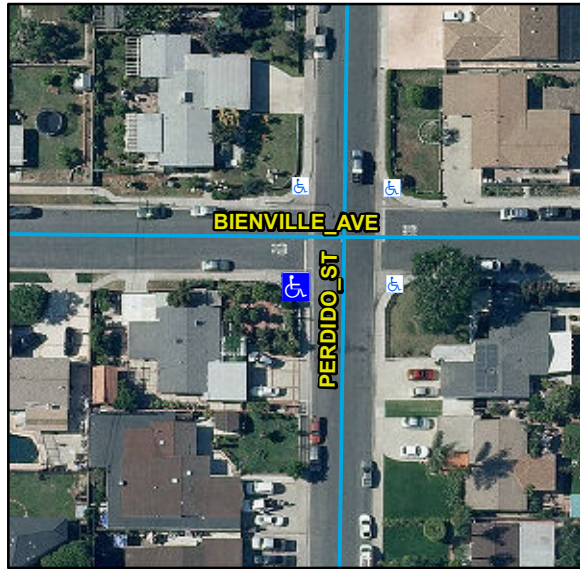
| Compliance | Description | Data | Compliance | Description | Data |
|---|---|---|---|---|---|
| No | Gutter Cross Slope (%) | 2.2 | Yes | Perpendicular Joint Present | Yes |

Remove & Replace Gutter.

R304.5.3, STD 1115
