# Access Compliance Report Public Rights-of-Way (Curb Ramps)

Main Street: BIENVILLE\_AVE Cross Street: ANTIGUA\_ST Location: NW

ADA ID: RPAT211118111352 Ramp Type: Type 4 - Parallel Initial Pass/Fail: Pass Overall Compliance: Yes Severity Score: 0

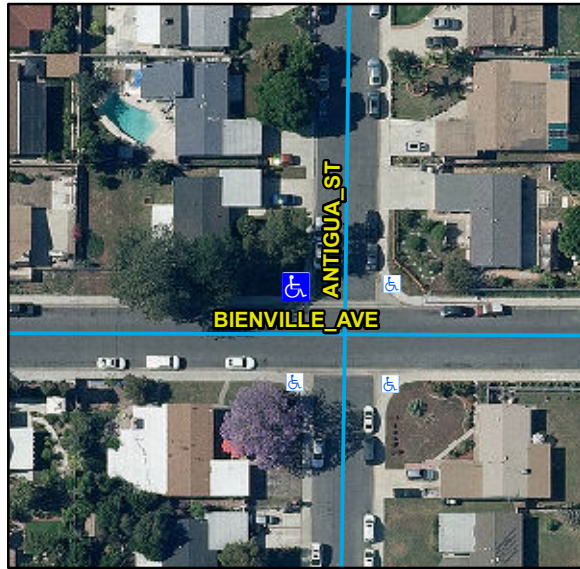
| Compliance | Description | Data | Compliance | Description | Data |
|---|---|---|---|---|---|
| N/A | Ramp Length LT (in) | 75 | N/A | Ramp Length RT (in) | 78 |
| Yes | Ramp Width LT (in) | 54 | Yes | Ramp Width RT (in) | 55 |
| Yes | Ramp Run Slope LT (%) | 6.7 | Yes | Ramp Run Slope RT (%) | 0.7 |
| Yes | Ramp Cross Slope LT (%) | 1.3 | Yes | Ramp Cross Slope RT (%) | 1.1 |
| N/A | Landing Present | Yes | Yes | DWS Provided | Yes |
| N/A | Landing Length (in) | 54 | Yes | DWS Contrast | Yes |
| Yes | Landing Width (in) | 48 | Yes | DWS Length (in) | 36 |
| Yes | Landing Run Slope (%) | 1.6 | Yes | DWS Full Width | Yes |
| Yes | Landing Cross Slope (%) | 0.1 | | DWS Offset Type | Single |
| Yes | Overall Surface Condition | Acceptable | | | |

N/A
