# Access Compliance Report Public Rights-of-Way (Curb Ramps)

Main Street: ANTIGUA\_ST Cross Street: BIENVILLE\_AVE Location: NE

ADA ID: RPAT211118111739 Ramp Type: Type 4 - Parallel Initial Pass/Fail: Pass Overall Compliance: No Severity Score: 5

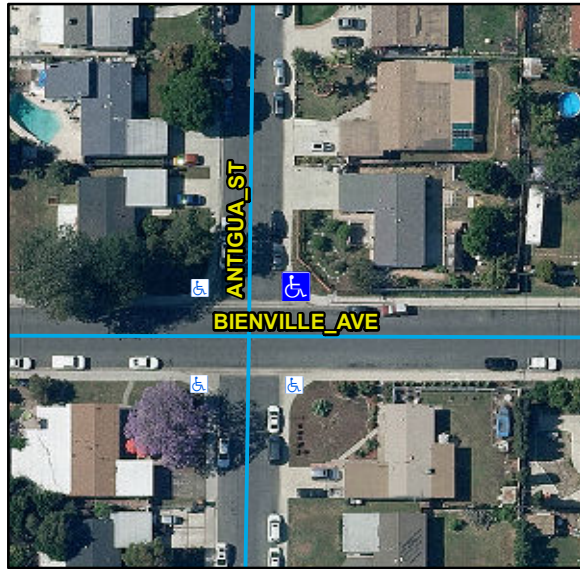
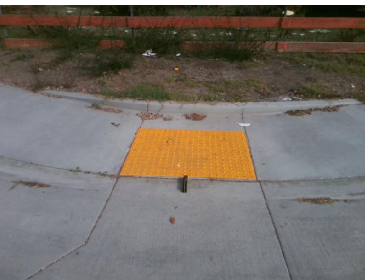
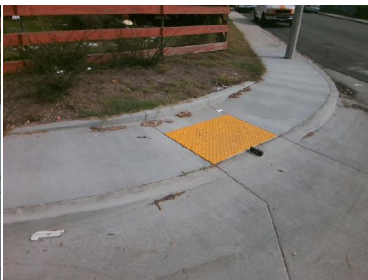
| Compliance | Description | Data | Compliance | Description | Data |
|---|---|---|---|---|---|
| No | Gutter Run Slope (%) | 5.2 | | Road Cross Slope (%) | 3.1 |

Remove & Replace Gutter.

R304.5.4, STD 1115
